Inspection Report

MH060108-LH060635

Street INT. Billings Dr & Bennington	Use of Sewer Sanitary	Upstream MH LH060635
City City of Superior	Drainage Area District 6	Dowstream MH MH060108
Loc. details	Flow Control	Dir. of Survey Upstream
Location Code Light Highway	Length surveyed 211.32 ft	Section Length 211.32 ft

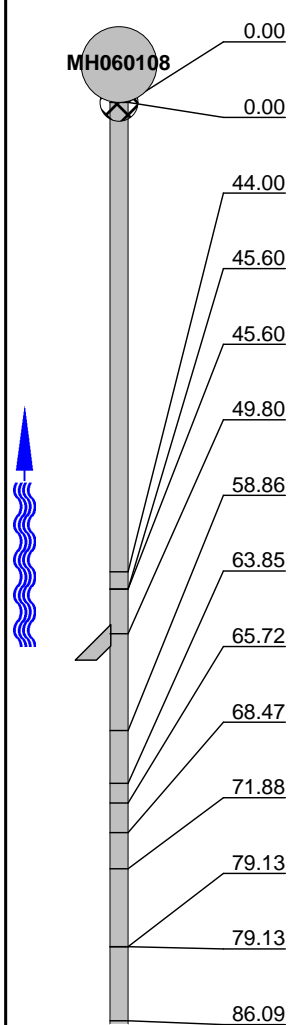
1:216	Position	Code	Observation	Photo	Grade
	0.00	AMH	Manhole, MH060108 / MH060108		
	0.00	MWL	Water Level, 5 % of cross sectional area		
	44.00	S1 B	Broken, from 12 o'clock, to 12 o'clock, Start

45.60	ID	Infiltration Dropper, at 12 o'clock		
	45.60	B	Broken, from 12 o'clock, to 12 o'clock		
	49.80	TFD	Tap Factory Made Defective, at 2 o'clock, 6 inch dim, 6 inch defective

58.86	DAE	Deposits Attached Encrustation, 5 % of cross sectional area, from 8 o'clock, to 10 o'clock		
	63.85	DAE	Deposits Attached Encrustation, 5 % of cross sectional area, from 7 o'clock, to 11 o'clock

65.72	DAE	Deposits Attached Encrustation, 5 % of cross sectional area, from 8 o'clock, to 12 o'clock		
	68.47	ID	Infiltration Dropper, at 1 o'clock		
	71.88	DAE	Deposits Attached Encrustation, 5 % of cross sectional area, from 7 o'clock, to 12 o'clock

79.13	S2 CM	Crack Multiple, from 12 o'clock, to 12 o'clock, Start		
	79.13	E1 B	Broken, from 12 o'clock, to 12 o'clock, Finish		
	86.09	FL	Fracture Longitudinal, at 6 o'clock
