Inspection report

Date: 7/20/2021	Work Order:	Weather: Dry	Surveyed By: Steven Bucklin	Certificate Number: U-0819-70306510	Pipe Segment Ref.: CB010016-CB01016A
Year laid:	Pre-cleaning: Light Cleaning	Direction: Upstream	Pipe Joint Length:	Total Length: 39.0'	Length Surveyed: 39.0'

City: City of Superior	Drainage Area:	Upstream MH: CB01016A
Street: N 4TH ST	Media Label: 1080	Up Rim to Invert: 0.0
Location Code: Local rural streets with light traffic	Flow Control: Not Controlled	Downstream MH: CB010016
Location Details:	Sheet Number:	Down Rim to Invert: 0.0
Pipe shape: Circular	Sewer Use: Stormwater Pipe	Total gallons used: 0.0
Pipe size: 12"	Sewer Category: SEC	Joints passed: 0
Pipe material: Reinforced Concrete Pipe	Purpose: Routine Assessment	Joints failed: 0
Lining Method: None	Owner: City of Superior (ESD)

Section Pictures - 7/20/2021 - CB010016-CB01016A

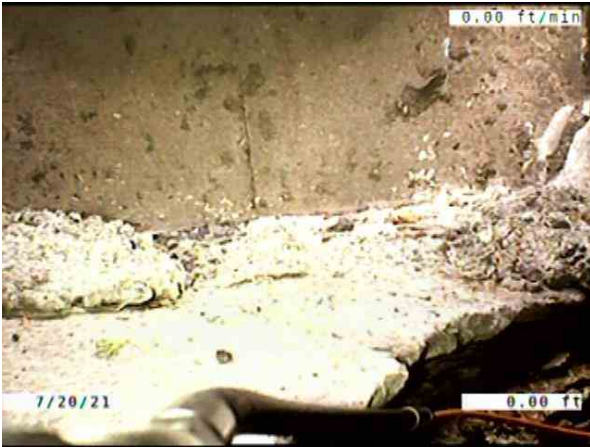
CB010016-CB01016A_4986dda5-b245-4260-84ef-57f3ec271a33_20210720_174858_647.jpg, 00:00:01, 0.00ft
 Catch Basin / CB010016

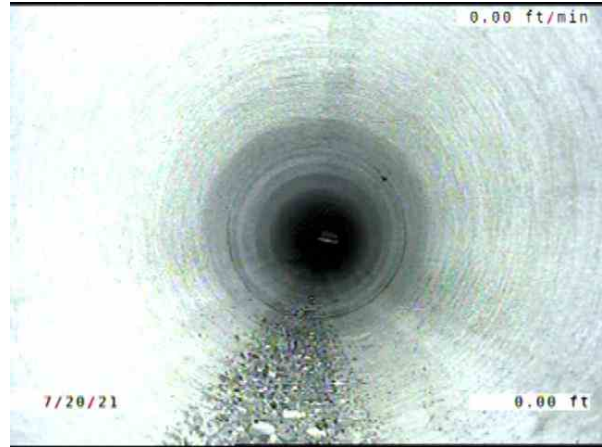
CB010016-CB01016A_4096145c-3f2d-44c3-a1f3-6e053ae5775c_20210720_174914_867.jpg, 00:00:10, 0.00ft
 Water Level, 0% of the vertical dimension

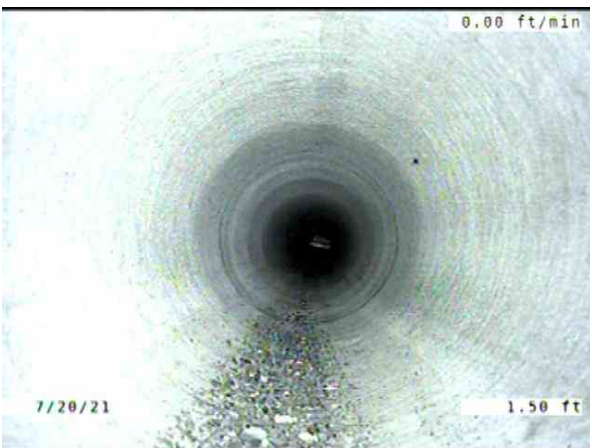
CB010016-CB01016A_65cdb412-3ed1-418b-b2f2-6ed5fb821c80_20210720_175612_172.jpg, 00:00:18, 1.50ft
 Miscellaneous General Observation / DROP INTO THE CATCH BASIN. HAD TO START IN THE PIPE.

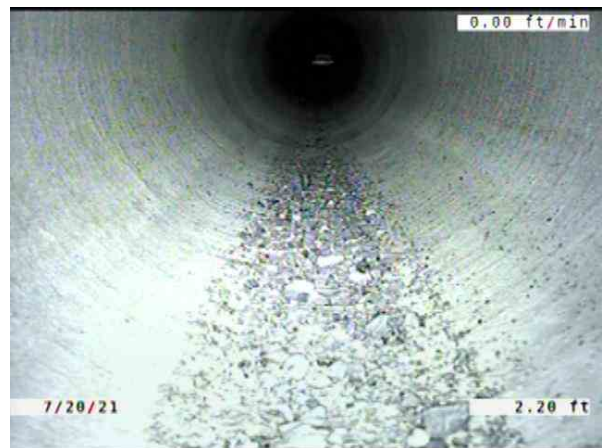
CB010016-CB01016A_edb52a8a-8cc7-4f19-a29d-e89346bb57f3_20210720_175649_226.jpg, 00:00:39, 2.20ft
 Deposits Settled Fine, 5% of cross sectional area from 5 o'clock to 7 o'clock, within 8 inch, Start

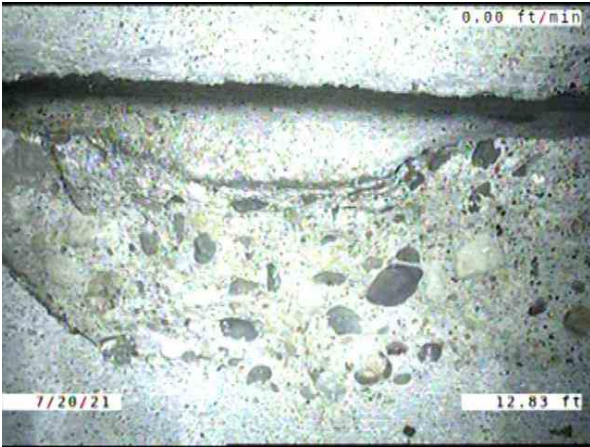
CB010016-CB01016A_be4d500a-e86d-4cd7-9a37-62a679d782f1_20210720_180339_917.jpg, 00:01:32, 12.83ft
Surface Other at 9 o'clock, within 8 inch / A PIECE CHIPPED AWAY FROM THE JOINT

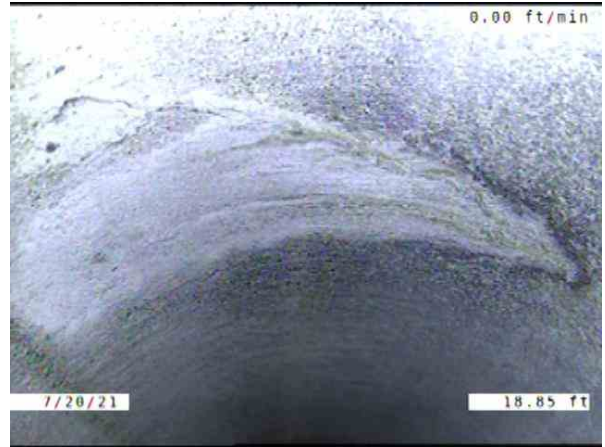
CB010016-CB01016A_00420518-e71d-4bd5-a80d-f774cb44c3a7_20210720_180540_556.jpg, 00:03:12, 18.85ft
Infiltration Stain Barrel from 6 o'clock to 12 o'clock, within 8 inch

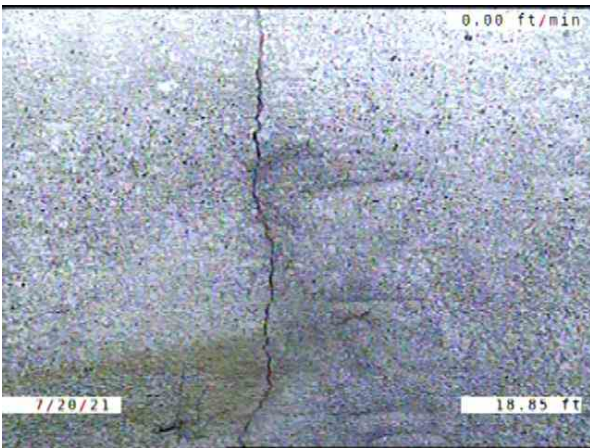
CB010016-CB01016A_f33129ff-9715-4f85-b52f-c733b4d8ba61_20210720_180506_000.jpg, 00:02:47, 18.85ft
Crack Multiple from 4 o'clock to 12 o'clock, within 8 inch, Start

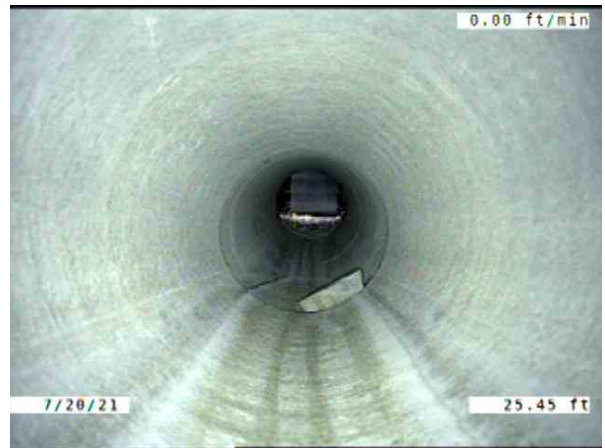
CB010016-CB01016A_b5863c2f-b0e4-4595-a674-2fb0ae384d43_20210720_180628_792.jpg, 00:03:56, 25.45ft
Deposits Settled Fine, 5% of cross sectional area from 5 o'clock to 7 o'clock, within 8 inch, Finish

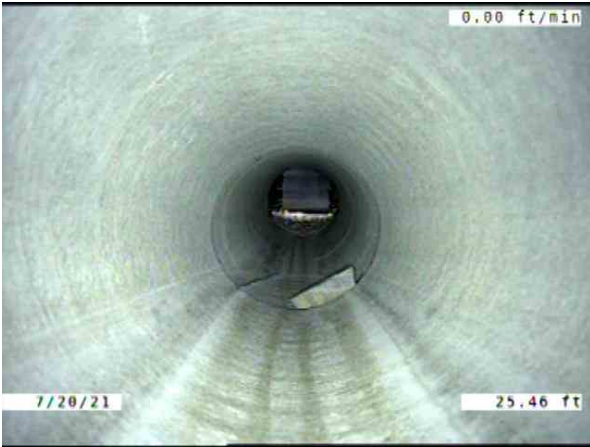
CB010016-CB01016A_8af9cc66-3db8-4760-8e84-a8409a051a45_20210720_180652_406.jpg, 00:04:05, 25.46ft
Crack Multiple from 4 o'clock to 12 o'clock, within 8 inch, Finish

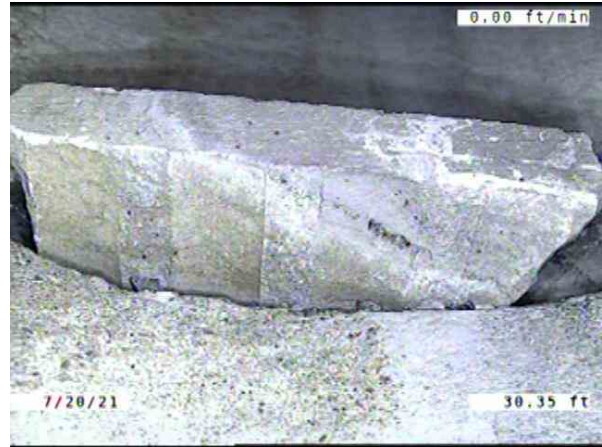
CB010016-CB01016A_060db97e-219d-450f-9333-9e583b1b32df_20210720_180749_288.jpg, 00:04:36, 30.35ft
Obstruction Wedged In The Joint, 10% of cross sectional area from 4 o'clock to 6 o'clock, within 8 inch / LOOKS LIKE A PIECE OF TILE

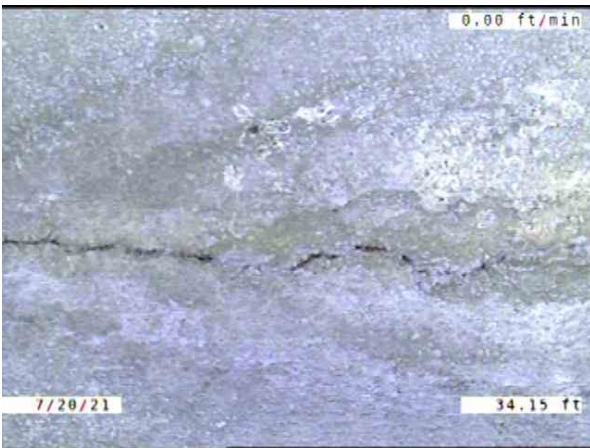
CB010016-CB01016A_b0af1ef9-d983-4076-a33f-e91eb4c8ed24_20210720_180856_841.jpg, 00:05:34, 34.15ft
Crack Circumferential from 12 o'clock to 12 o'clock

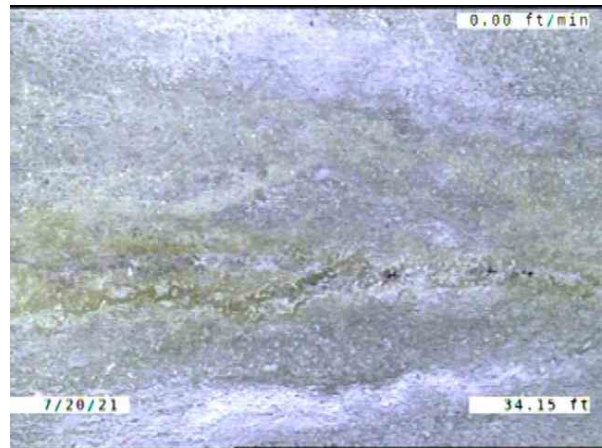
CB010016-CB01016A_2205b232-f031-45b9-9468-de8d3b2974b6_20210720_180915_663.jpg, 00:05:48, 34.15ft
Infiltration Stain Barrel from 7 o'clock to 5 o'clock

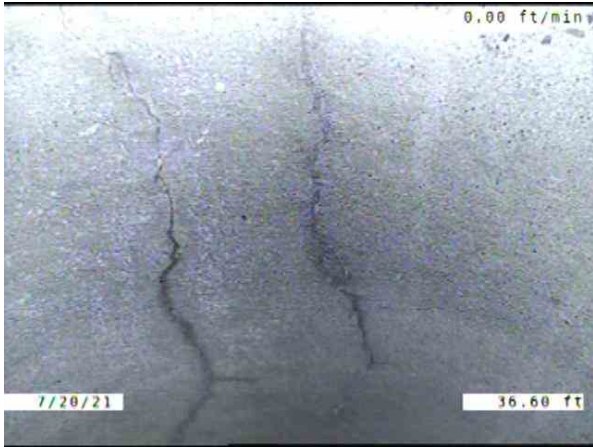
CB010016-CB01016A_c4b215dc-f011-491b-9157-d68e0f862a
c6_20210720_181058_186.jpg, 00:07:16, 36.60ft
Crack Multiple from 9 o'clock to 5 o'clock, within 8 inch

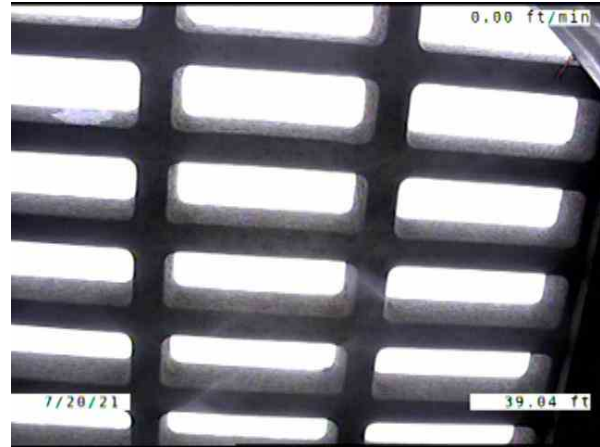
CB010016-CB01016A_ed73b532-0884-43d7-8aeb-fc74f8339
d06_20210720_181247_957.jpg, 00:09:02, 39.04ft
Catch Basin / CB01016A
