## Inspection report

Date: <b>7/23/2021</b>	Work Order:	Weather: <b>Dry</b>	Surveyed By: <b>Steven Bucklin</b>	Certificate Number: <b>U-0819-70306510</b>	Pipe Segment Ref.: <b>CB010025-CB01065B</b>
Year laid:	Pre-cleaning: <b>Light Cleaning</b>	Direction: <b>Downstream</b>	Pipe Joint Length:	Total Length: <b>76.0'</b>	Length Surveyed: <b>19.9'</b>

City: <b>City of Superior</b>	Drainage Area:	Upstream MH: <b>CB01065B</b>
Street: <b>OGDEN AVE</b>	Media Label: <b>1080</b>	Up Rim to Invert: <b>0.0</b>
Location Code: <b>Local rural streets with light traffic</b>	Flow Control: <b>Not Controlled</b>	Downstream MH: <b>CB010025</b>
Location Details: <b>UNDER EARTH RIDER BREWERY'S FE</b>	Sheet Number:	Down Rim to Invert: <b>0.0</b>
Pipe shape: <b>Circular</b>	Sewer Use: <b>Stormwater Pipe</b>	Total gallons used: <b>0.0</b>
Pipe size: <b>12"</b>	Sewer Category: <b>SEC</b>	Joints passed: <b>0</b>
Pipe material: <b>Reinforced Concrete Pipe</b>	Purpose: <b>Routine Assessment</b>	Joints failed: <b>0</b>
Lining Method: <b>None</b>	Owner: <b>City of Superior (ESD)</b>

## Section Pictures - 7/23/2021 - CB010025-CB01065B

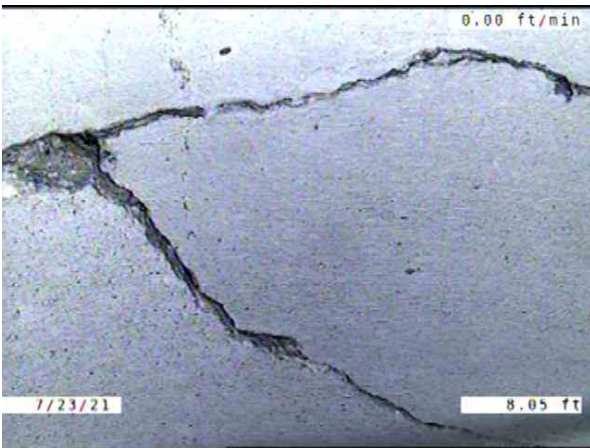
8.1	B	Broken from 12 o'clock to 12 o'clock	00:02:25	CB010025 -CB01065 B_bed548	S4		
	10.5	S01 SAV	Surface Damage Aggregate Visible from 12 o'clock to 12 o'clock, within 8 inch, Start	00:03:19	CB010025 -CB01065 B_67719e

CB010025-CB01065B\_bed54896-3772-4112-b642-b8fd2ed5188f\_20210723\_125836\_161.jpg, 00:02:25, 8.05ft  
Broken from 12 o'clock to 12 o'clock

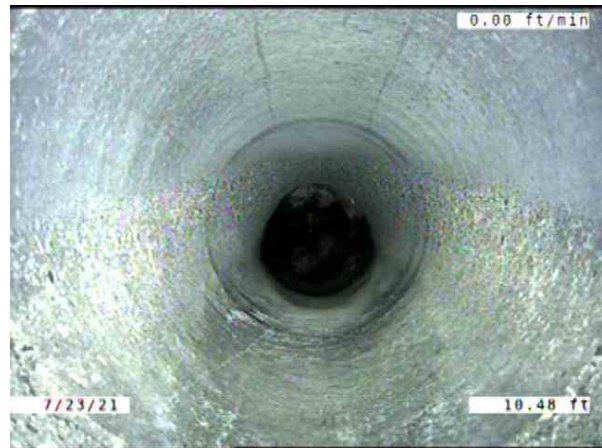
CB010025-CB01065B\_c53109af-2e1b-470e-9483-cb1390b7a348\_20210723\_125949\_214.jpg, 00:03:19, 10.48ft  
Surface Damage Aggregate Visible from 12 o'clock to 12 o'clock, within 8 inch, Start

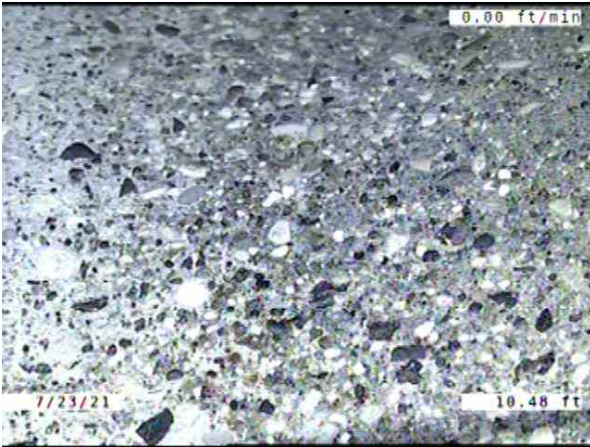
CB010025-CB01065B\_67719e4b-8ec2-45bd-a992-b97a42db27c2\_20210723\_125956\_295.jpg, 00:03:19, 10.48ft  
Surface Damage Aggregate Visible from 12 o'clock to 12 o'clock, within 8 inch, Start

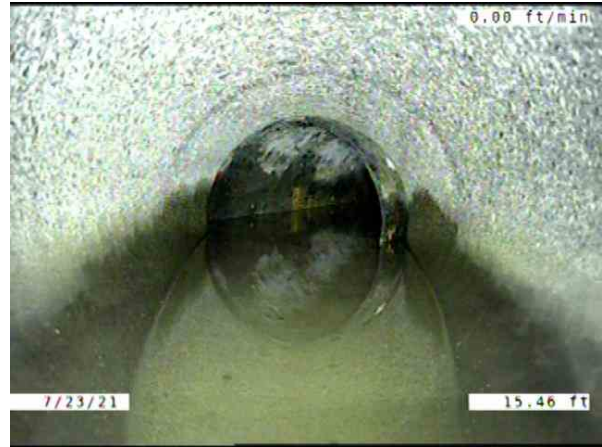
CB010025-CB01065B\_28069e5c-82cf-478d-8b1e-73ede41c5d48\_20210723\_130054\_635.jpg, 00:04:10, 15.46ft  
Water Level, 25% of the vertical dimension

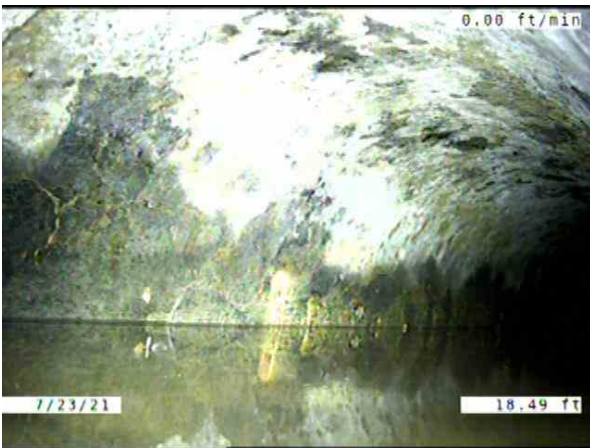
15.5	MWL	Water Level, 25% of the vertical dimension	00:04:10	CB010025 -CB01065 B_28069e			
	18.5	LR	Line Right, change to: 50%	00:05:06	CB010025 -CB01065 B_0a0824	M4

CB010025-CB01065B\_0a082442-c604-4f75-9a25-e84b6719b6d3\_20210723\_130210\_742.jpg, 00:05:06, 18.49ft  
Line Right, change to: 50%

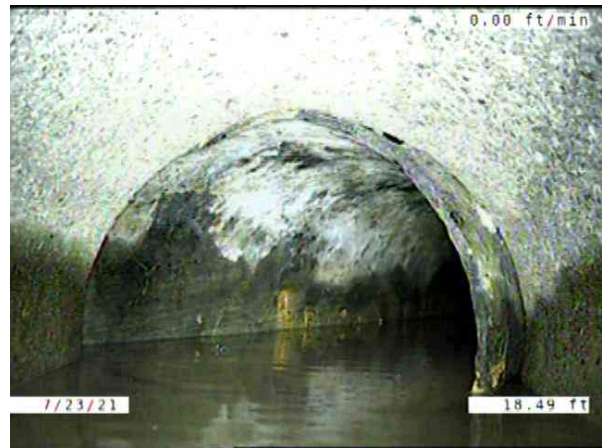
CB010025-CB01065B\_4a566221-a057-4cc2-87ba-d21c614eb53e\_20210723\_130219\_344.jpg, 00:05:06, 18.49ft  
Line Right, change to: 50%

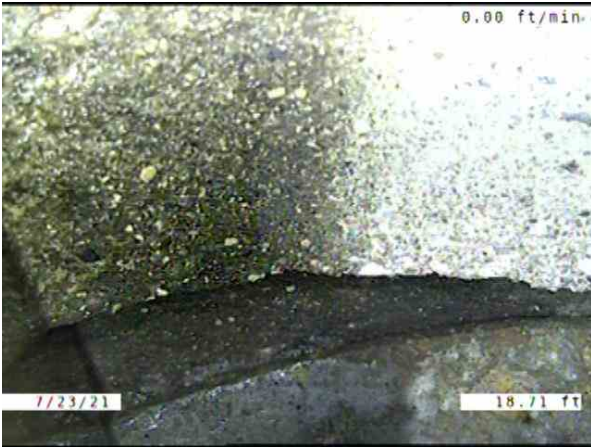
18.7	JAL	Joint Angular Large	00:05:47	CB010025 -CB01065 B_e33b9d	S4		
	18.7	MMC	Miscellaneous Material Change, Ductile Iron Pipe / RCP TO DIP	00:06:02	CB010025 -CB01065 B_ddb843

CB010025-CB01065B\_e33b9d45-e3e6-4953-b095-a23f23cdc64b\_20210723\_130253\_053.jpg, 00:05:47, 18.71ft  
Joint Angular Large

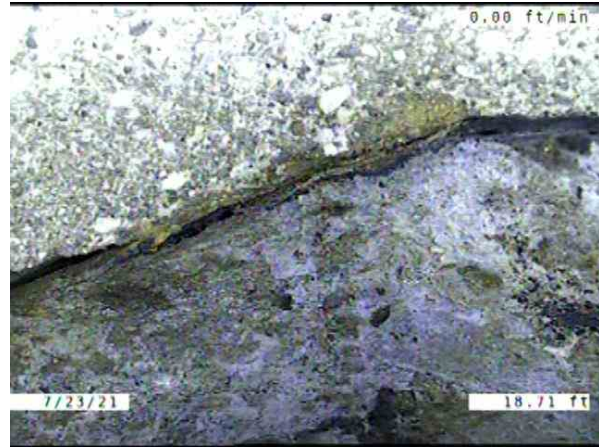
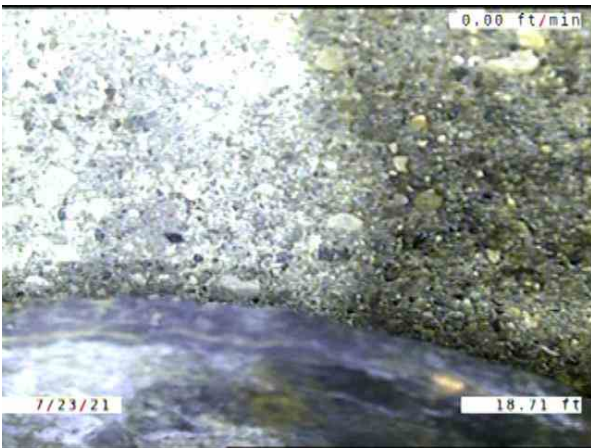
CB010025-CB01065B\_ddb84318-948d-4677-9ebb-0a364f747f03\_20210723\_130326\_419.jpg, 00:06:02, 18.71ft  
Miscellaneous Material Change, Ductile Iron Pipe / RCP TO DIP

CB010025-CB01065B\_85aaec56-e5ac-447a-8fc2-e34f6335c7b9\_20210723\_130334\_851.jpg, 00:06:02, 18.71ft  
Miscellaneous Material Change, Ductile Iron Pipe / RCP TO DIP

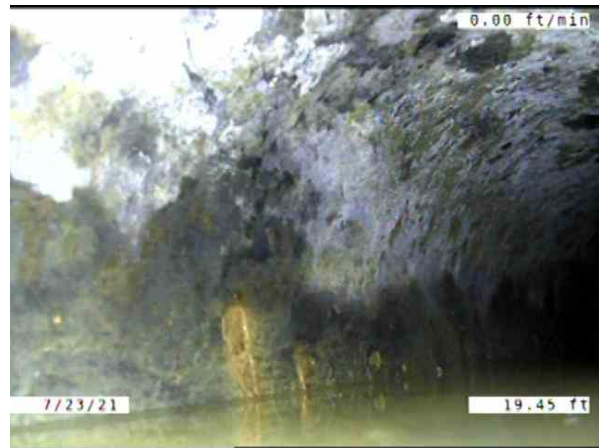
19.5	F01 SAV	Surface Damage Aggregate Visible from 12 o'clock to 12 o'clock, within 8 inch, Finish	00:06:34	CB010025 -CB01065 B_719ae1	S2		
	19.9	SSC	Surface Spalling of Damage Coating from 9 o'clock to 3 o'clock, within 8 inch	00:08:03	CB010025 -CB01065 B_851a55	S1

CB010025-CB01065B\_719ae133-4872-43aa-9934-81379db87ee9\_20210723\_130403\_108.jpg, 00:06:34, 19.45ft  
Surface Damage Aggregate Visible from 12 o'clock to 12 o'clock, within 8 inch, Finish

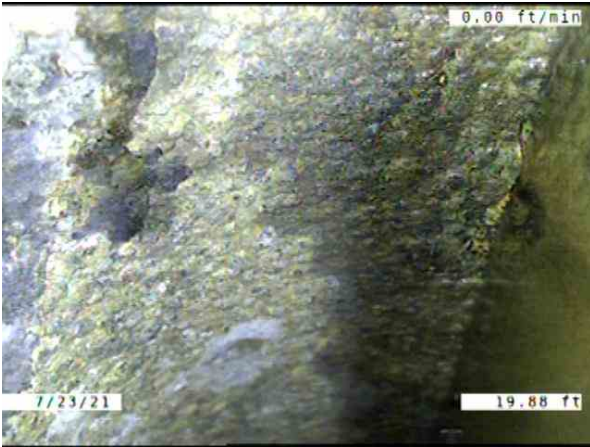
CB010025-CB01065B\_851a551f-b992-4e5d-96b6-e7666cfb1002\_20210723\_130630\_248.jpg, 00:08:03, 19.88ft  
 Surface Spalling of Damage Coating from 9 o'clock to 3 o'clock, within 8 inch

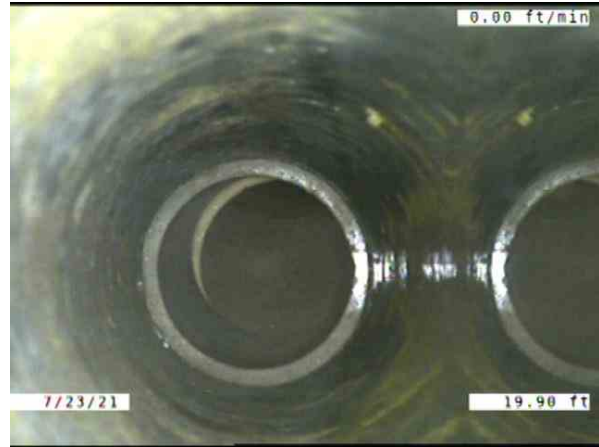
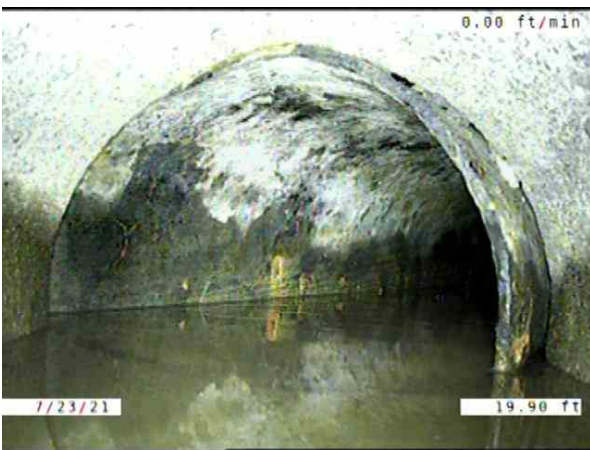
19.9	MSA	Miscellaneous Survey Abandoned / CAMERA CANT MAKE IT PAST THE ANGLED JOINT	00:08:19	CB010025 -CB01065 B_932083			
	76.0		End of pipe					
<b>CB010025</b>								
QSR	QMR	QOR	SPR	MPR	OPR	SPRI	MPRI	OPRI
4222	4100	4322	13.0	4.0	17.0	2.6	4.0	2.8

CB010025-CB01065B\_f186cc2f-0b90-4ada-a29e-0e4d25d8bcb3\_20210723\_130845\_363.jpg, 00:08:19, 19.90ft  
 Miscellaneous Survey Abandoned / CAMERA CANT MAKE IT PAST THE ANGLED JOINT

CB010025-CB01065B\_932083d0-5c72-4a21-a2c2-394ed3a39dfb\_20210723\_130918\_336.jpg, 00:08:19, 19.90ft  
 Miscellaneous Survey Abandoned / CAMERA CANT MAKE IT PAST THE ANGLED JOINT
