Inspection report

Section Pictures - 7/23/2021 - CB01001B-CB01001C

City	Street	Date	Pipe Segment Reference	Section No.
City of Superior	TOWER AVE	7/23/2021	CB01001B-CB01001C	143

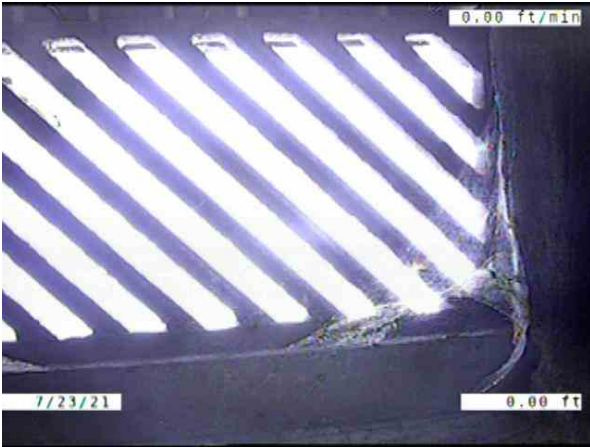
CB01001B-CB01001C_71a754d9-a457-4b2e-9fd0-6f83ff3f17b8_20210723_163605_371.jpg, 00:00:01, 0.00ft
Catch Basin / CB01001B

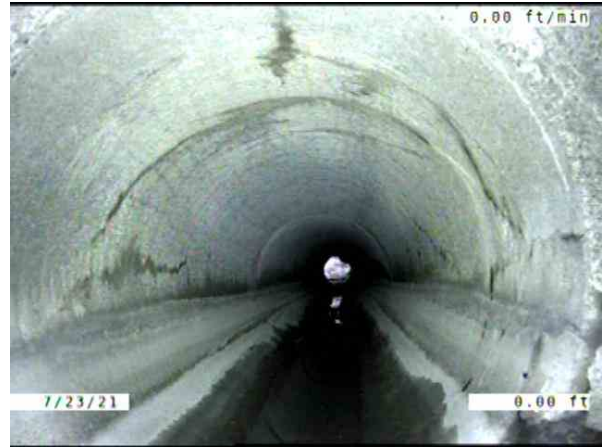
CB01001B-CB01001C_6b125917-7479-4761-9334-b49d9704cc46_20210723_163731_066.jpg, 00:01:25, 0.00ft
Water Level, 5% of the vertical dimension

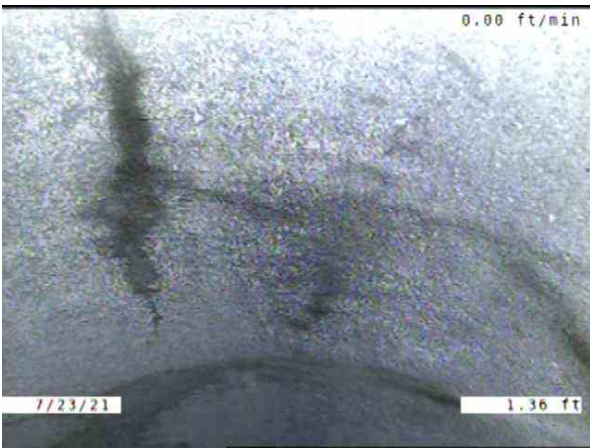
CB01001B-CB01001C_1e2fb72f-201c-42d5-9126-ac1d85421c4f_20210723_163842_684.jpg, 00:02:30, 1.36ft
Crack Multiple from 12 o'clock to 12 o'clock, within 8 inch, Start

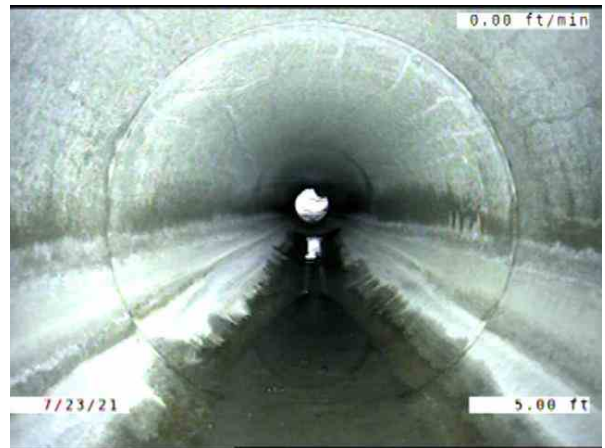
CB01001B-CB01001C_35ad9f59-5627-4e7c-ba6f-15be1e1ee5c9_20210723_163920_925.jpg, 00:03:03, 5.00ft
Crack Multiple from 12 o'clock to 12 o'clock, within 8 inch, Finish

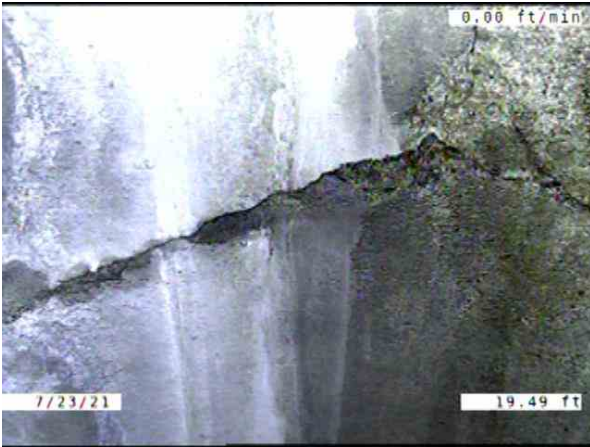
CB01001B-CB01001C_b21691ef-f58d-4c4a-8127-8b3cb49a4048_20210723_164124_797.jpg, 00:04:59, 19.49ft
Broken from 12 o'clock to 11 o'clock, within 8 inch

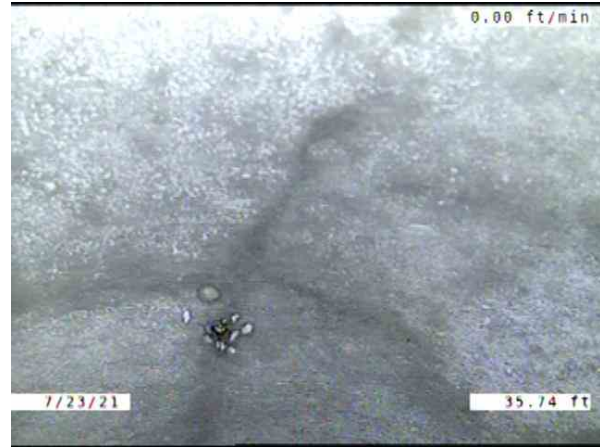
CB01001B-CB01001C_aa0a4938-e6d5-4f09-bb8d-a2ffdb32948e_20210723_164324_298.jpg, 00:06:50, 35.74ft
Crack Multiple from 10 o'clock to 5 o'clock, within 8 inch

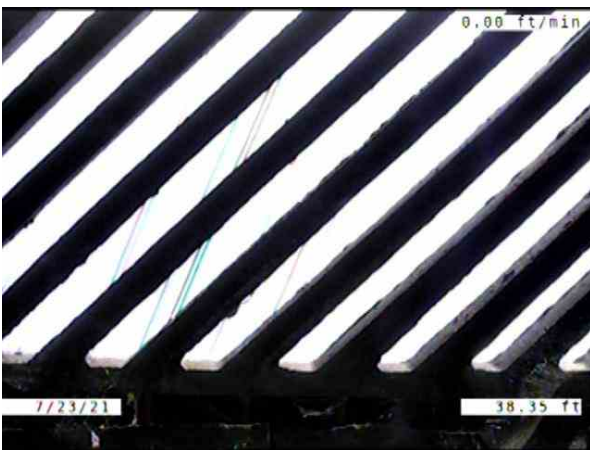
CB01001B-CB01001C_f4f1e9ba-f4af-4f23-ae0d-03f7c61c60db_20210723_164614_781.jpg, 00:08:43, 38.35ft
Catch Basin / CB01001C
