## Inspection report

## Section Pictures - 7/19/2021 - CB010024-CB010360

City	Street	Date	Pipe Segment Reference	Section No.
City of Superior	N 6TH ST	7/19/2021	CB010024-CB010360	75

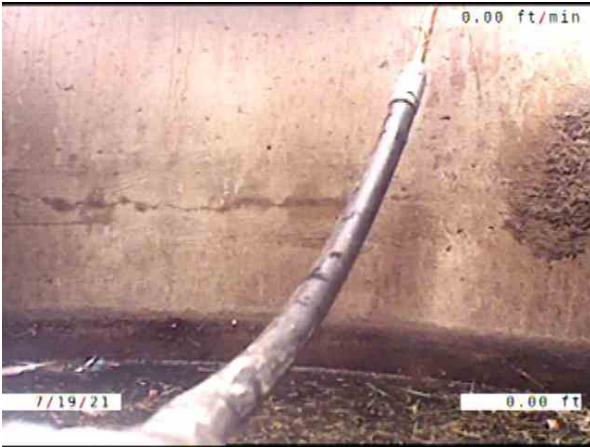
CB010024-CB010360\_a333811d-b985-4dd3-b822-49f9d0d35226\_20210719\_155755\_706.jpg, 00:00:01, 0.00ft  
Catch Basin / CB010024

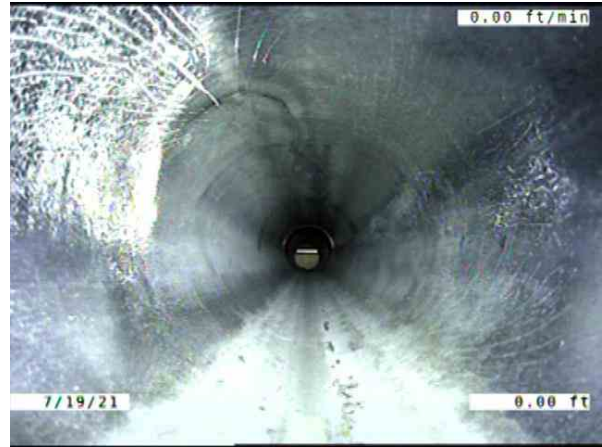
CB010024-CB010360\_0c12620f-3be9-4c96-b990-c4b1610e78bd\_20210719\_155814\_282.jpg, 00:00:10, 0.00ft  
Water Level, 0% of the vertical dimension

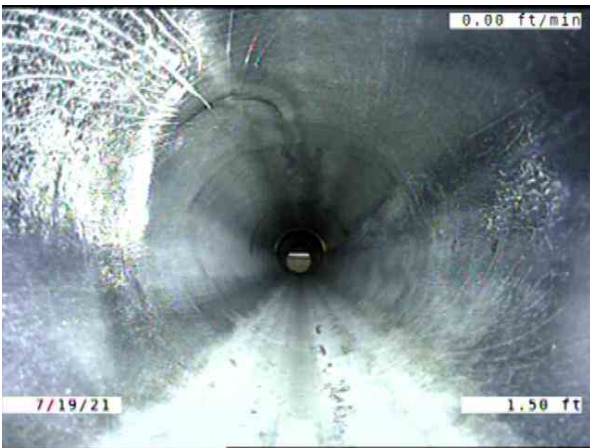
CB010024-CB010360\_cfb3fe89-6bf9-4ea6-8d8c-f9bad42dd560\_20210719\_155944\_433.jpg, 00:00:18, 1.50ft  
Miscellaneous General Observation / DROP INTO THE CATCH BASIN. HAD TO START IN THE PIPE.

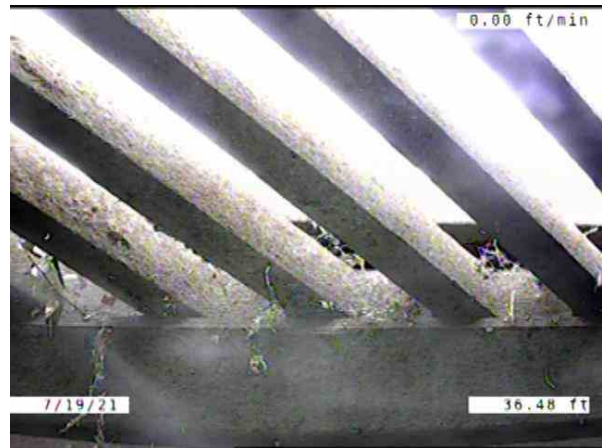
CB010024-CB010360\_e1f44e5c-7069-4958-b4b5-f3587ed259d7\_20210719\_160418\_814.jpg, 00:04:22, 36.48ft  
Catch Basin / CB010360
