Inspection report

Date:	Work Order:	Weather:	Surveyed By:	Certificate Number:	Pipe Segment Ref.:
5/10/2022		**Dry**	**Steven Bucklin**	**U-0819-70306510**	**MH060097-MH060107**
Year laid:	Pre-cleaning: **No Pre-Cleaning**	Direction: **Downstream**	Pipe Joint Length:	Total Length:	Length Surveyed:

City:	**City of Superior**	Drainage Area:		Upstream MH:	**MH060107**
Street:	**BILLINGS**	Media Label:	**1111**	Up Rim to Invert:	**0.0**
Location Code:	**Yard**	Flow Control:	**Not Controlled**	Downstream MH:	**MH060097**
Location Details:		Sheet Number:	**19**	Down Rim to Invert:	**0.0**
Pipe shape:	**Circular**	Sewer Use:	**Combined Pipe**	Total gallons used:	**0.0**
Pipe size:	**21**	Sewer Category:	**SEC**	Joints passed:	**0**
Pipe material:	**Vitrified Clay Pipe**	Purpose:	**Routine Assessment**	Joints failed:	**0**
Lining Method:	**None**	Owner:	**City of Superior**		
Additional Info:

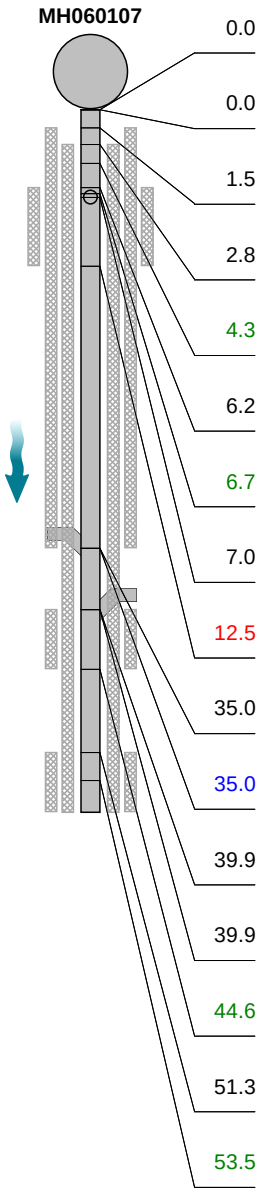
1:603	Distance		Code	Observation	Counter	Photo	Grade
	0.0		AMH	Manhole / MH060107	00:00:01	MH060097-MH060107_1c78d55	
	0.0		MWL	Water Level, 5% of the vertical dimension	00:01:47	MH060097-MH060107_dc2803a

1.5	S01	MWLS	Miscellaneous Water Level, Sag, 5% of the vertical dimension, Start	00:02:12	MH060097-MH060107_adbdf07	
	2.8	S02	DSF	Deposits Settled Fine, 5% of cross sectional area from 5 o'clock to 7 o'clock, within 8 inch, Start	00:02:35	MH060097-MH060107_b49811

4.3		OBN	Obstruction Construction Debris, 10% of cross sectional area from 5 o'clock to 7 o'clock, within 8 inch	00:03:05	MH060097-MH060107_ac6df68	M2

6.2	S03	B	Broken from 6 o'clock to 3 o'clock, within 8 inch, Start	00:04:48	MH060097-MH060107_235c57d	
	6.7		OBN	Obstruction Construction Debris, 5% of cross sectional area from 5 o'clock to 6 o'clock, within 8 inch	00:06:35	MH060097-MH060107_3c75b92	M2

7.0		TFD	Tap Factory Made Defective at 12 o'clock, dia/height: 6inch, within 8 inch / CAPPED. TAP BROKEN	00:07:22	MH060097-MH060107_a913d7	M3
	12.5	F03	B	Broken from 6 o'clock to 3 o'clock, within 8 inch, Finish	00:08:35	MH060097-MH060107_71aa74c	S4

35.0		TF	Tap Factory Made at 1 o'clock, dia/height: 6inch, within 8 inch / SERVICE ANGLED INTO THE TAP.	00:10:54	MH060097-MH060107_4f5c696	
	35.0	F01	MWLS	Miscellaneous Water Level, Sag, 5% of the vertical dimension, Finish	00:11:08		S2

39.9		TFD	Tap Factory Made Defective at 11 o'clock, dia/height: 6inch, within 8 inch / TAP BROKEN. SERVICE ANGLED AND OFFSET. SOIL VISIBLE.	00:11:42	MH060097-MH060107_c487574	M3

39.9	S04	OBN	Obstruction Construction Debris, 10% of cross sectional area from 5 o'clock to 7 o'clock, Start, within 8 inch / PIECES OF PIPE. ROCKS. CONCRETE.	00:12:14	MH060097-MH060107_23f39ec

44.6	F04	OBN	Obstruction Construction Debris, 10% of cross sectional area from 5 o'clock to 7 o'clock, Finish, within 8 inch / PIECES OF PIPE. ROCKS. CONCRETE.	00:13:25	MH060097-MH060107_c9803c7	M2

51.3	S05	MWLS	Miscellaneous Water Level, Sag, 5% of the vertical dimension, Start	00:14:08	MH060097-MH060107_49345e	
	53.5		RFJ	Roots Fine Joint at 2 o'clock, within 8 inch	00:14:28	MH060097-MH060107_b6014b	M1

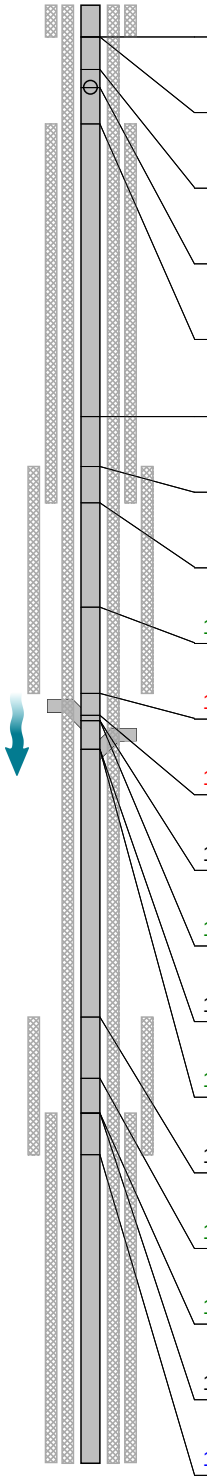
1:603	Distance		Code	Observation	Counter	Photo	Grade
	58.6	F05	MWLS	Miscellaneous Water Level, Sag, 5% of the vertical dimension, Finish	00:15:18	MH060097-MH060107_b15e12	S2

58.6		RFJ	Roots Fine Joint at 8 o'clock, within 8 inch	00:15:37	MH060097-MH060107_6e4f653	M1
	61.2		RFJ	Roots Fine Joint from 7 o'clock to 5 o'clock, within 8 inch	00:16:45	MH060097-MH060107_fd7f8c9	M1

62.6		TFC	Tap Factory Made Capped at 12 o'clock, dia/height: 6inch, within 8 inch	00:17:20	MH060097-MH060107_337d14	
	65.5	S06	MWLS	Miscellaneous Water Level, Sag, 5% of the vertical dimension, Start	00:17:56	MH060097-MH060107_de7761f

88.9		SZ	Surface Other at 2 o'clock, within 8 inch / A PIECE CHIPPED AWAY FROM THE JOINT.	00:19:55	MH060097-MH060107_c0128df	
	92.9	S07	SSS	Surface Damage Spalling from 9 o'clock to 3 o'clock, within 8 inch, Start	00:20:43	MH060097-MH060107_f73a295

95.8	F06	MWLS	Miscellaneous Water Level, Sag, 5% of the vertical dimension, Finish	00:21:26	MH060097-MH060107_22a4bc6	S2
	104.1		OBZ	Obstruction Other, 5% of cross sectional area from 5 o'clock to 7 o'clock, within 8 inch / UNKNOWN DEBRIS UNDER THE TP AND RAGS	00:22:20	MH060097-MH060107_5d735a	M2

111.0	F07	SSS	Surface Damage Spalling from 9 o'clock to 3 o'clock, within 8 inch, Finish	00:23:33	MH060097-MH060107_26d427	S2
	112.7		HSV	Hole Soil Visible from 12 o'clock to 1 o'clock, within 8 inch	00:24:16	MH060097-MH060107_3019c5b	S5

113.1		TFD	Tap Factory Made Defective at 1 o'clock, dia/height: 6inch, within 8 inch / SOIL VISIBLE AROUND THE SERVICE. CONSTANTLY RUNNING WATER.	00:24:40	MH060097-MH060107_e843a4	M3

113.1		IDC	Infiltration Dripper Connection at 1 o'clock, within 8 inch	00:24:52	MH060097-MH060107_2ec91a8	M3
	115.4		TFC	Tap Factory Made Capped at 11 o'clock, dia/height: 6inch, within 8 inch	00:25:34	MH060097-MH060107_e5fbcd9

115.4		OBN	Obstruction Construction Debris, 5% of cross sectional area from 5 o'clock to 7 o'clock, within 8 inch	00:25:59	MH060097-MH060107_0e0e54	M2

136.7	S08	MWLS	Miscellaneous Water Level, Sag, 10% of the vertical dimension, Start	00:27:53	MH060097-MH060107_b0354d	
	141.6		RFJ	Roots Fine Joint from 1 o'clock to 2 o'clock, within 8 inch	00:29:02	MH060097-MH060107_5705d8	M1

144.4		RFJ	Roots Fine Joint from 12 o'clock to 1 o'clock, within 8 inch	00:29:39	MH060097-MH060107_b0928d	M1
	144.4	S09	FM	Fracture Multiple from 12 o'clock to 12 o'clock, within 8 inch, Start	00:30:04	MH060097-MH060107_b160f49

147.7	F08	MWLS	Miscellaneous Water Level, Sag, 10% of the vertical dimension, Finish	00:30:33	MH060097-MH060107_2e62ef8	S2

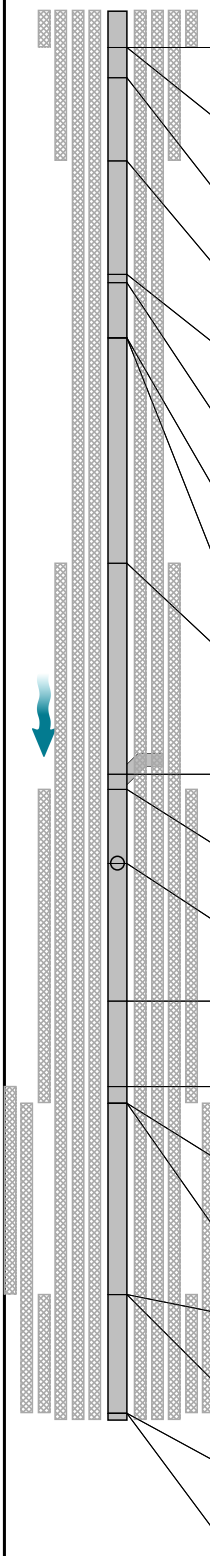
1:603 Distance		Code	Observation	Counter	Photo	Grade
281.1		JAM	Joint Angular Medium	00:52:58	MH060097-MH060107_dbcc608	S3
281.1	F12	B	Broken from 8 o'clock to 4 o'clock, within 8 inch, Finish	00:53:11	MH060097-MH060107_6ed37b	S4

283.4		SZ	Surface Other at 3 o'clock, within 8 inch / A PIECE CHIPPED AWAY FROM THE JOINT.	00:54:03	MH060097-MH060107_3d8922	
290.1	F11	MWLS	Miscellaneous Water Level, Sag, 10% of the vertical dimension, Finish	00:55:37	MH060097-MH060107_ef3867f	S2

299.2		RFJ	Roots Fine Joint from 8 o'clock to 4 o'clock, within 8 inch	00:57:29	MH060097-MH060107_70a9de	M1
299.8		MWLS	Miscellaneous Water Level, Sag, 5% of the vertical dimension	00:58:03	MH060097-MH060107_0c086d2	S2

304.2		JAM	Joint Angular Medium	00:59:05	MH060097-MH060107_4a5762	S3
304.2		RFJ	Roots Fine Joint at 4 o'clock, within 8 inch	00:59:20	MH060097-MH060107_28dabb	M1

322.2	S13	RFJ	Roots Fine Joint from 7 o'clock to 5 o'clock, Start, within 8 inch	01:02:15	MH060097-MH060107_b950e3	
339.0		TFD	Tap Factory Made Defective at 11 o'clock, dia/height: 6inch, within 8 inch / CAPPED. CAP BROKEN. ROOTS GROWING AROUND THE CAP.	01:03:54	MH060097-MH060107_751809	M3

340.2	S14	RFB	Roots Fine Barrell from 11 o'clock to 1 o'clock, Start	01:04:31	MH060097-MH060107_1e6b3c1	
346.1		TFD	Tap Factory Made Defective at 12 o'clock, dia/height: 6inch, within 8 inch / CAPPED. CAP BROKEN, TAP BROKEN.	01:05:12	MH060097-MH060107_830377	M3

357.1		DSGV	Deposits Settled Gravel, 5% of cross sectional area from 5 o'clock to 7 o'clock, within 8 inch	01:06:57	MH060097-MH060107_620678c	M2
363.9	S15	LR	Line Right, change to: 5%, Start	01:08:29	MH060097-MH060107_af64e3f

365.2	S16	JAM	Joint Angular Medium, Start	01:09:20	MH060097-MH060107_e654fc9	
365.2	F14	RFB	Roots Fine Barrell from 11 o'clock to 1 o'clock, Finish	01:09:36	MH060097-MH060107_803991	M2

380.5	S17	MWLS	Miscellaneous Water Level, Sag, 5% of the vertical dimension, Start	01:11:49	MH060097-MH060107_c0f6888	
380.5	F15	LR	Line Right, change to: 5%, Finish	01:11:56	MH060097-MH060107_7c778db	M1

389.9	F17	MWLS	Miscellaneous Water Level, Sag, 5% of the vertical dimension, Finish	01:12:40	MH060097-MH060107_33092af	S2
389.9	F16	JAM	Joint Angular Medium, Finish	01:12:48	MH060097-MH060107_2d3199c	S3
