## Inspection report

Date: <b>7/23/2021</b>	Work Order:	Weather: <b>Dry</b>	Surveyed By: <b>Steven Bucklin</b>	Certificate Number: <b>U-0819-70306510</b>	Pipe Segment Ref.: <b>CB010025-CB01065B</b>
Year laid:	Pre-cleaning: <b>Light Cleaning</b>	Direction: <b>Downstream</b>	Pipe Joint Length:	Total Length: <b>76.0'</b>	Length Surveyed: <b>19.9'</b>

City: <b>City of Superior</b>	Drainage Area:	Upstream MH: <b>CB01065B</b>
Street: <b>OGDEN AVE</b>	Media Label: <b>1080</b>	Up Rim to Invert: <b>0.0</b>
Location Code: <b>Local rural streets with light traffic</b>	Flow Control: <b>Not Controlled</b>	Downstream MH: <b>CB010025</b>
Location Details: <b>UNDER EARTH RIDER BREWERY'S FE</b>	Sheet Number:	Down Rim to Invert: <b>0.0</b>
Pipe shape: <b>Circular</b>	Sewer Use: <b>Stormwater Pipe</b>	Total gallons used: <b>0.0</b>
Pipe size: <b>12"</b>	Sewer Category: <b>SEC</b>	Joints passed: <b>0</b>
Pipe material: <b>Reinforced Concrete Pipe</b>	Purpose: <b>Routine Assessment</b>	Joints failed: <b>0</b>
Lining Method: <b>None</b>	Owner: <b>City of Superior (ESD)</b>

## Section Pictures - 7/23/2021 - CB010025-CB01065B

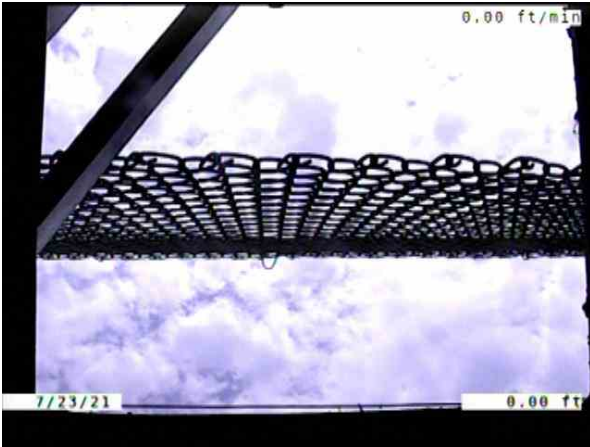
CB010025-CB01065B\_cdc857f8-3cee-46ba-9f8d-5377dcc34c55\_20210723\_125605\_957.jpg, 00:00:01, 0.00ft  
Catch Basin / CB01065B

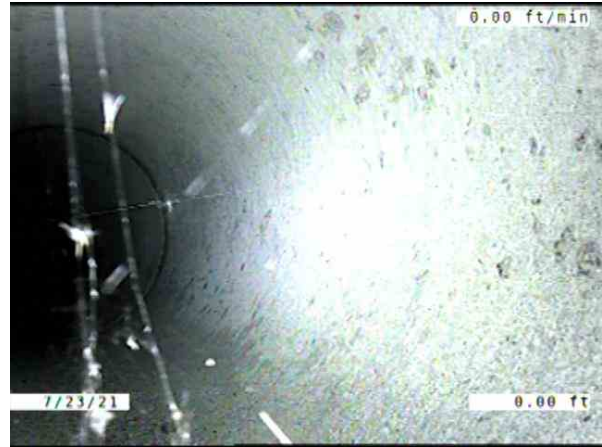
CB010025-CB01065B\_4d8a84bd-efa4-4b53-bf4c-1015eaf0bc5e\_20210723\_125705\_322.jpg, 00:01:01, 0.00ft  
Water Level, 0% of the vertical dimension
