## Inspection Report

MH060112-MH060114

Street <b>Culdesack on St. Albans</b>	Use of Sewer <b>Sanitary</b>	Upstream MH <b>MH060114</b>
City <b>City of Superior</b>	Drainage Area <b>District 6</b>	Downstream MH <del>MH06112A</del> MH060112
Loc. details	Flow Control	Dir. of Survey <b>Downstream</b>
Location Code <b>Light Highway</b>	Length surveyed <b>413.29 ft</b>	Section Length <b>413.29 ft</b>

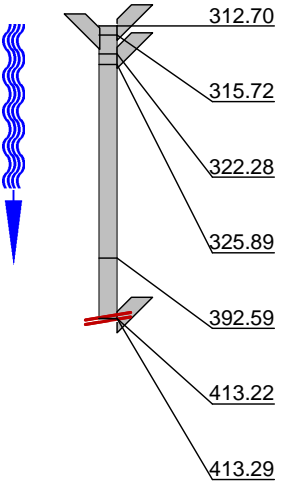
1:792	Position	Code	Observation	Photo	Rate

<u>312.70</u>	TFA	Tap Factory Made Active, at 9 o'clock, 8 inch dim CONNECTION FROM IN060558				
	<u>315.72</u>	TFA	Tap Factory Made Active, at 3 o'clock, 8 inch dim CONNECTION from MH060113				
	<u>322.28</u>	TFC	Tap Factory Made Capped, at 9 o'clock, 8 inch dim				
	<u>325.89</u>	CM	Crack Multiple, from 11 o'clock, to 3 o'clock, within 8 inch				
	<u>392.59</u>	D	Deformed, 5 % changed				
	<u>413.22</u>	TBA	Tap Break-In Active, at 10 o'clock, 4 inch dim				
	<u>413.29</u>	MSA	Survey Abandoned, intruding tap / intruding tap				
QSR	QMR	SPR	MPR	OPR	SPRI	MPRI	OPRI
