Inspection Report

MH06112A-MH060114

Date 4/25/2019	P/O. No.	Weather Dry	Surveyor's Name Josh Gordon	Pipe Segment Reference MH060114 - MH06112A	Section No. 8
Certificate No. U-215-06023623	Survey Customer	System Owner	Preset :	Pre-Cleaning No Pre-Cleaning	Sewer Category

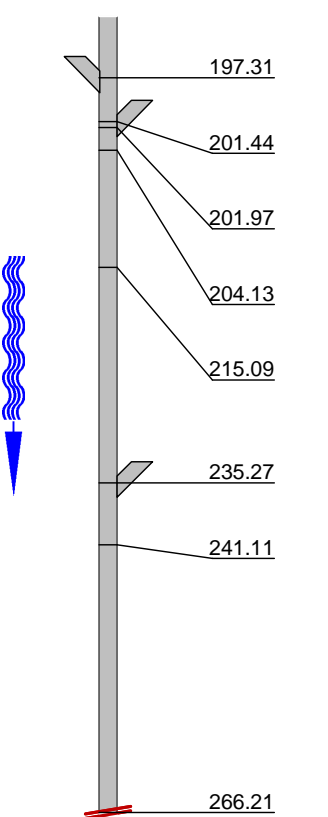
197.31	TFA	Tap Factory Made Active, at 3 o'clock, 6 inch dim				
	201.44	TFA	Tap Factory Made Active, at 9 o'clock, 6 inch dim				
	201.97	CL	Crack Longitudinal, at 11 o'clock, within 8 inch				
	204.13	CL	Crack Longitudinal, at 12 o'clock, within 8 inch				
	215.09	MWM	Water Mark, 100 % of cross sectional area				
	235.27	TFC	Tap Factory Made Capped, at 9 o'clock, 6 inch dim				
	241.11	CL	Crack Longitudinal, at 11 o'clock, within 8 inch				
	266.21	MSA	Survey Abandoned, wheels spinning / wheels spinning				
QSR	QMR	SPR	MPR	OPR	SPRI	MPRI	OPRI
